A Simple yet Effective Way to Prevent Loose Metal Debris When Removing Cold-Welded Titanium Locking Plates: A Case Report

CASE REPORT

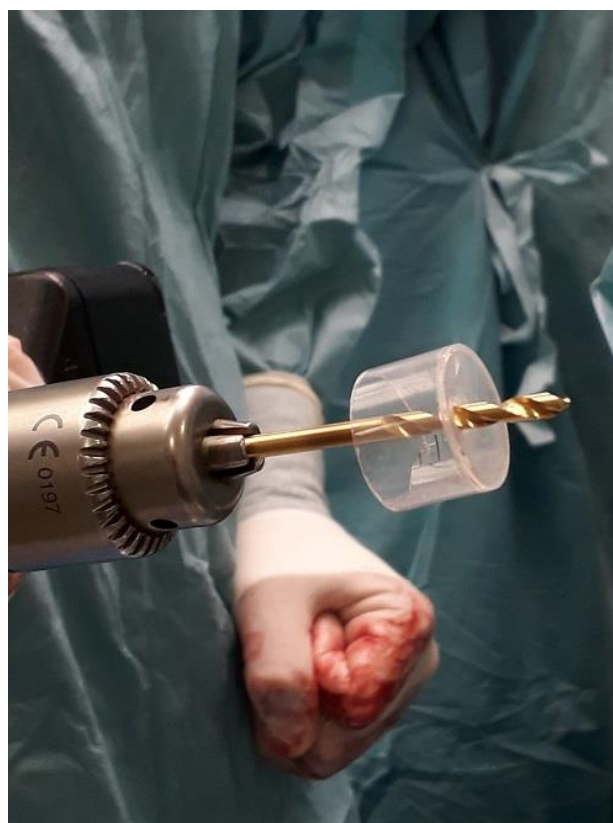
Figure 1. A hole is drilled in the top of a 10 cc plastic syringe that was cut in half.

This technique was used in a single case in October 2017. A 15 year old male successfully healed a right distal femur fracture three months after being treated with a titanium LCP distal femur plate. Removal of the implants was indicated because of persistent complaints of pain. Removal of 4 proximal screws was unproblematic, but 1 unicortical and 2 bicortical distal screws were found to be cold-welded. Multiple attempts were made to remove them in the manner described in the introduction, however unsuccessfully, after which the screw heads were stripped. To make removal of the screws and plate possible, a carbide drill from the Synthes screw removal set was used to obliterate the screw heads. Before drilling, a 10cc plastic syringe was cut in half, and a hole was drilled in the top

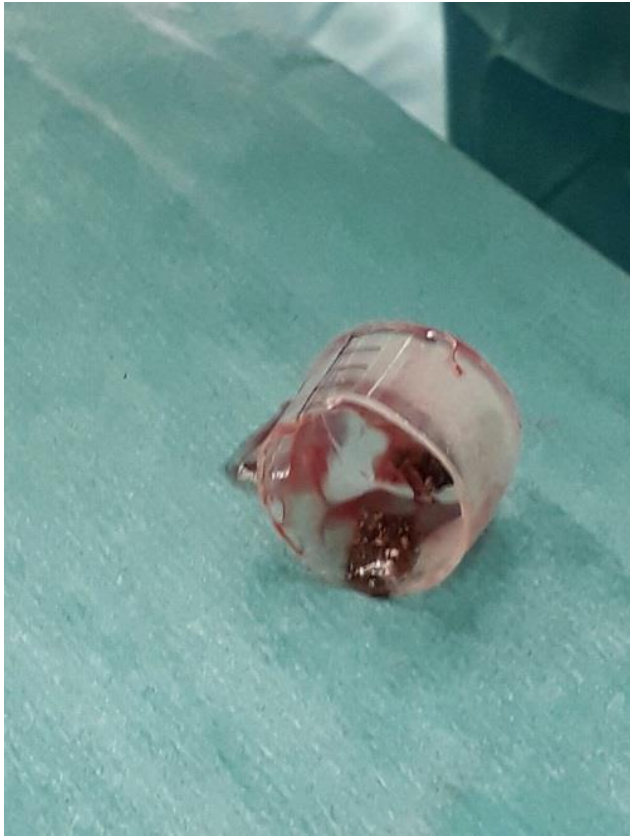
Figure 3. Metal debris is intercepted in the collection basket as they fall from the notches of the drillbit.

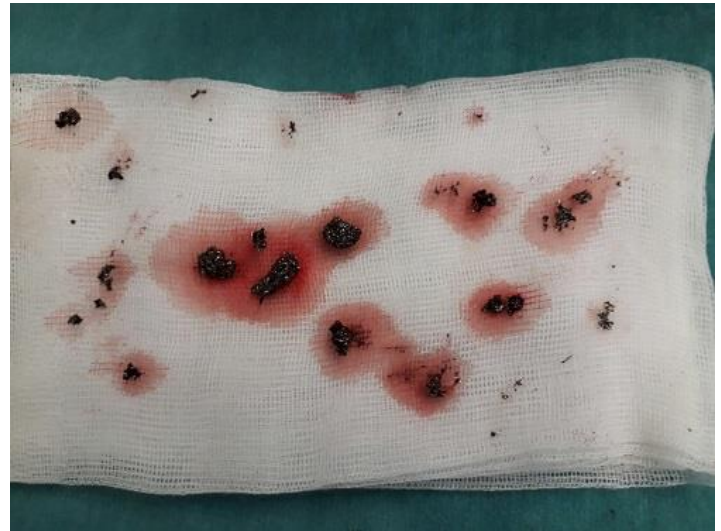
Figure 4. The collection basket is emptied in a gauze.
